# Pathways and challenges toward a socio-ecological transformation

## **FIELD REPORT: PRACTICAL TRAINING ON GULLY REHABILITATION USING VERTIVER GRASS AT CHEPUKAT LIVESTOCK CAFÉ SITE IN CHEPARERIA WARD, WEST POKOT COUNTY**

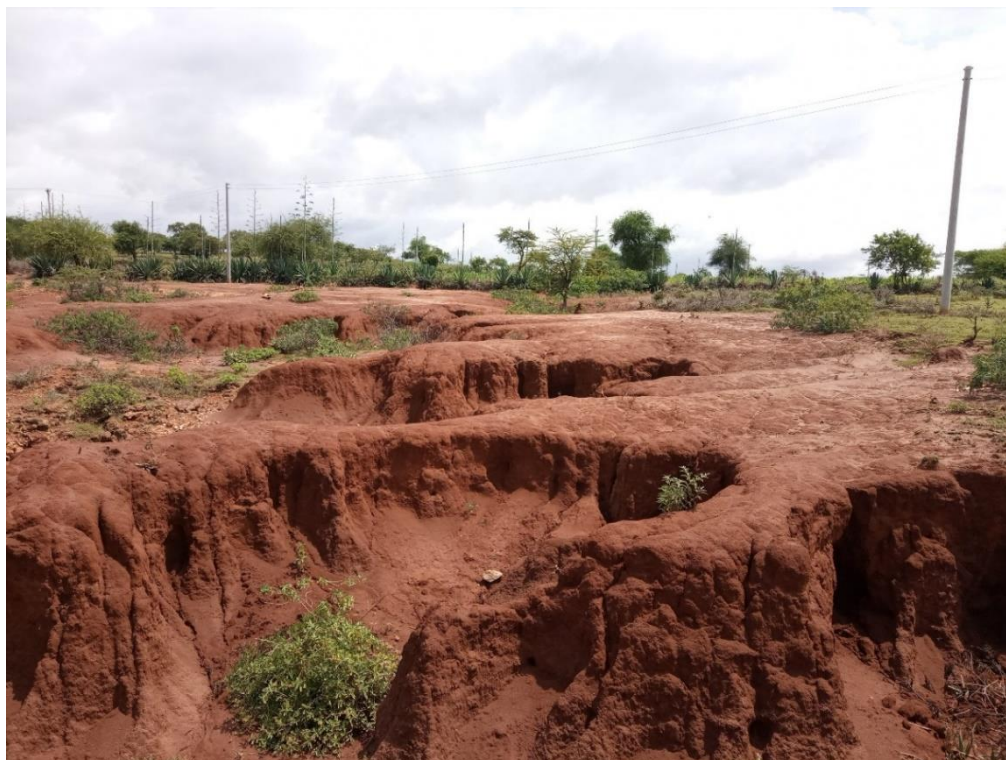
<sup>1</sup> Cover photo

<sup>1</sup>Gully erosion at the Livestock Café Main site in Chepareria. Photo by S. Mureithi

As an inexpensive and eco-friendly tool used worldwide to rehabilitate landscapes. Vetiver grass technology was applied at the Livestock Café site in Chepareria ward which is highly degraded with huge gullies occupying more than 50% of the site. The aim of objective two in the Drylands Transform project is to co-develop sustainable rangeland restoration and management options with the local communities and other stakeholders. Vetiver grass technology was initiated as a tool to rehabilitate the severely gullied part of the Livestock Café site in Chepukat village, Chepareria ward in West Pokot County, with a goal of showcasing it as a possible solution to the severely degraded hotspots in West Pokot County.

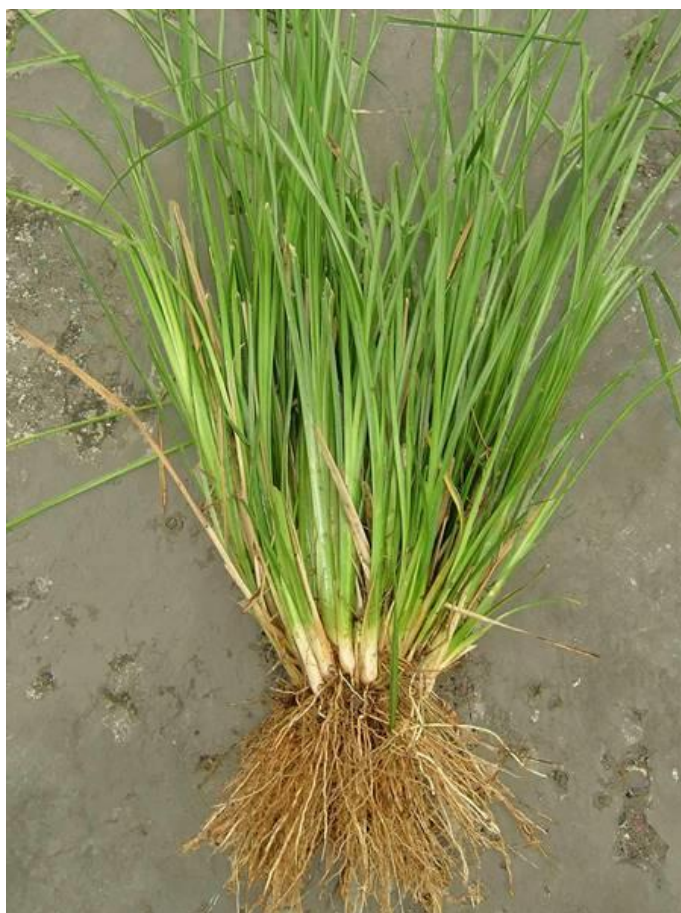
Fig. 1. *Chrysopogon zizanioides* (L. Roberty) commonly known as Vetiver grass.

Vetiver is a tall, tufted, perennial, scented grass with a straight stem, long narrow leaves and a root system that is abundant, complex and extensive (Fig. 1; Balasankar et al., 2013). It plays a vital role in watershed protection by slowing down and spreading runoff harmlessly on the farmland, recharging groundwater, reducing siltation of drainage systems and water bodies, reducing agrochemicals loading into water bodies and rehabilitation of degraded soils (Osunsanya and Aliku, 2017). Vetiver grass can be easily established in both tropics and temperate regions of the world. It can survive in conditions where other plants cannot and this is due to its unique and superior physiological and morphological features. Some of these characteristics include a massive, fine-structured root system with high resistance to pests, diseases and fire, high efficiency in absorbing dissolved N, P, Hg, Cd and Pb in polluted water and a good and fast recovery rate after being affected by adverse conditions.

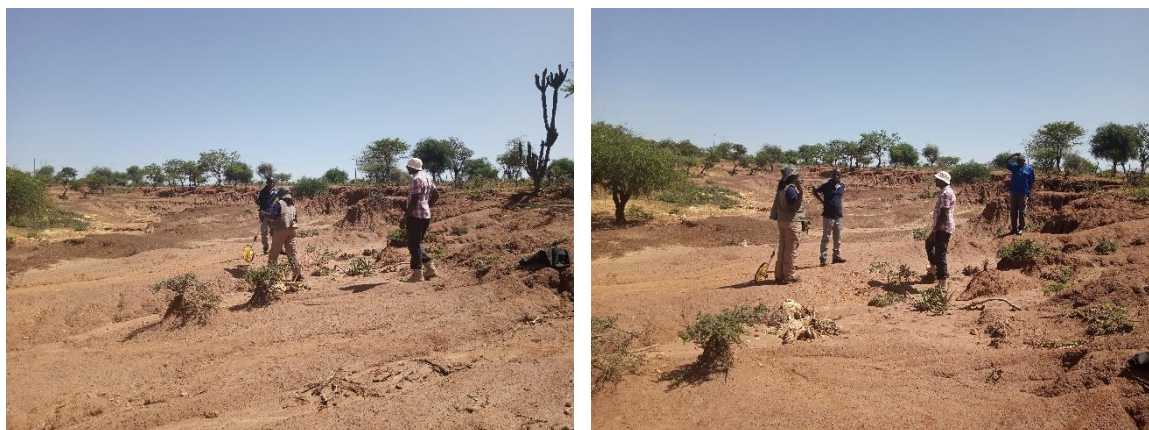
Fig. 2. The Dryland Transform Project Country Coordinator, Dr. Stephen Mureithi showing the site to the Vertiver Trainers from Jjaja Soil Solutions during the assignment and design (Photos by M Nyaga).

The Vertiver trainer, Jane Wegesa together with her assistant Andrew Wekesa and Dr. Stephen Mureithi surveyed the site taking the measurements of the gullies from the gully head (Fig. 1). The length of the gullies was 2,456m and the width was 405m. She designed that the main gullies would take 7 contour lines and more contours were concentrated at the gully head to reduce the pressure of surface run off down slope. The design also included reinforcement of the shoulders of the gully with bags and vetiver planted to deter further erosion.

The kitchen garden area was designed to have two countour lines to reduce the speed of surface runoff especially from the roadside. The length and the width of the Kitchen garden area were 1,012m and 286m, respectively.

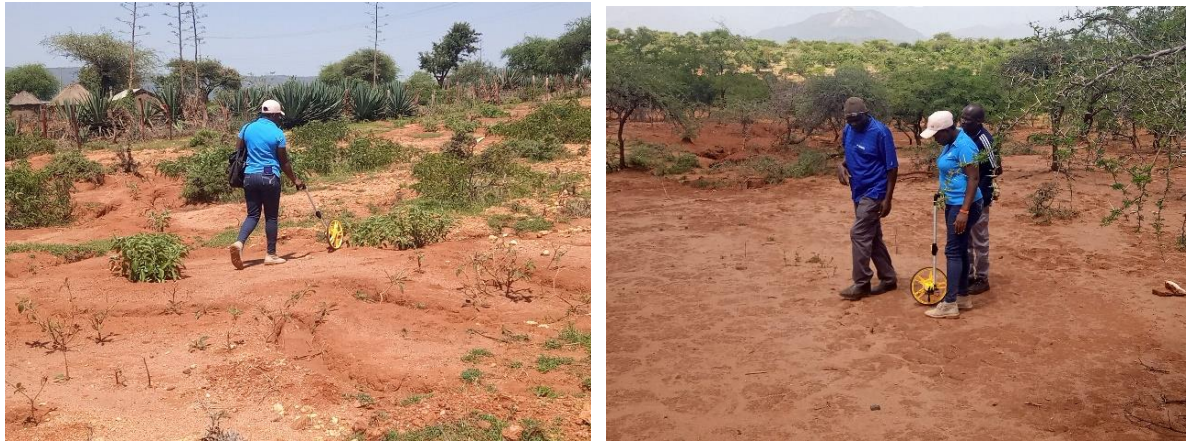
Fig. 3: Obj 2 PhD Student, Margeret Nyaga, measuring of the gullied area using the Digital Distance Measuring Wheel at the Chepareria Livestock Café sites (Photos by S Mureithi).

The gullies rehabilitation design was also extend to the Livestock Café Annex site, where there are experimental plots for the objective two PhD student, Margertet Nyaga (Fig. 3). The measurements for the gullies there were; length 1,841m and width 1,109m. The Livestock Café

Annex was thus designed to take 3 contour lines, and gully shoulders reinforced and some bags layed inside the gully planted with vetiver splits to slow down runoff and deter further erosion.

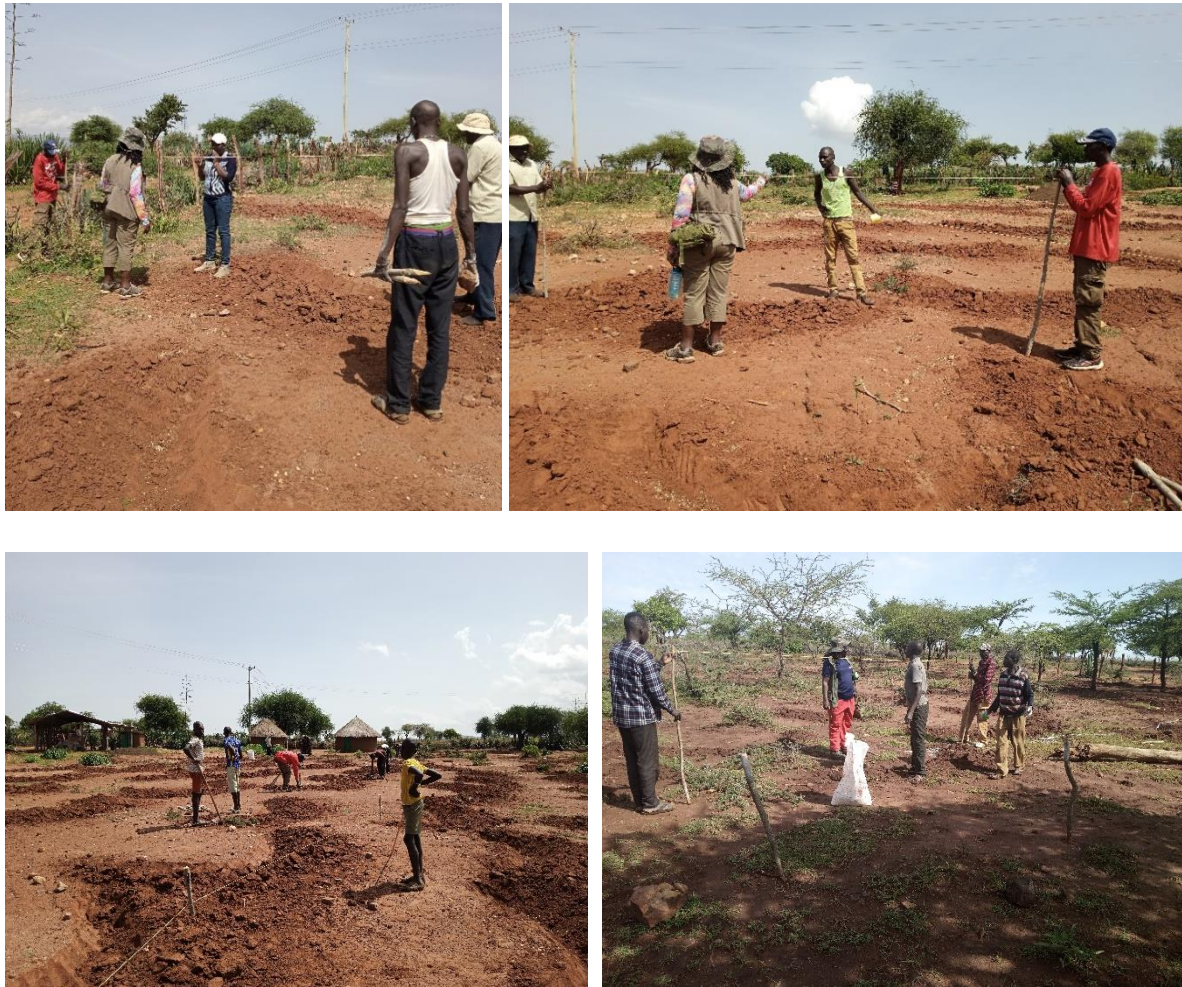
Fig 5: Determining and marking contours using a Line level and White ash (Photos by M Nyaga).

Then white ash is sprinkled to mark the contour along the line. The Line-level is the best for use gently sloping areas.

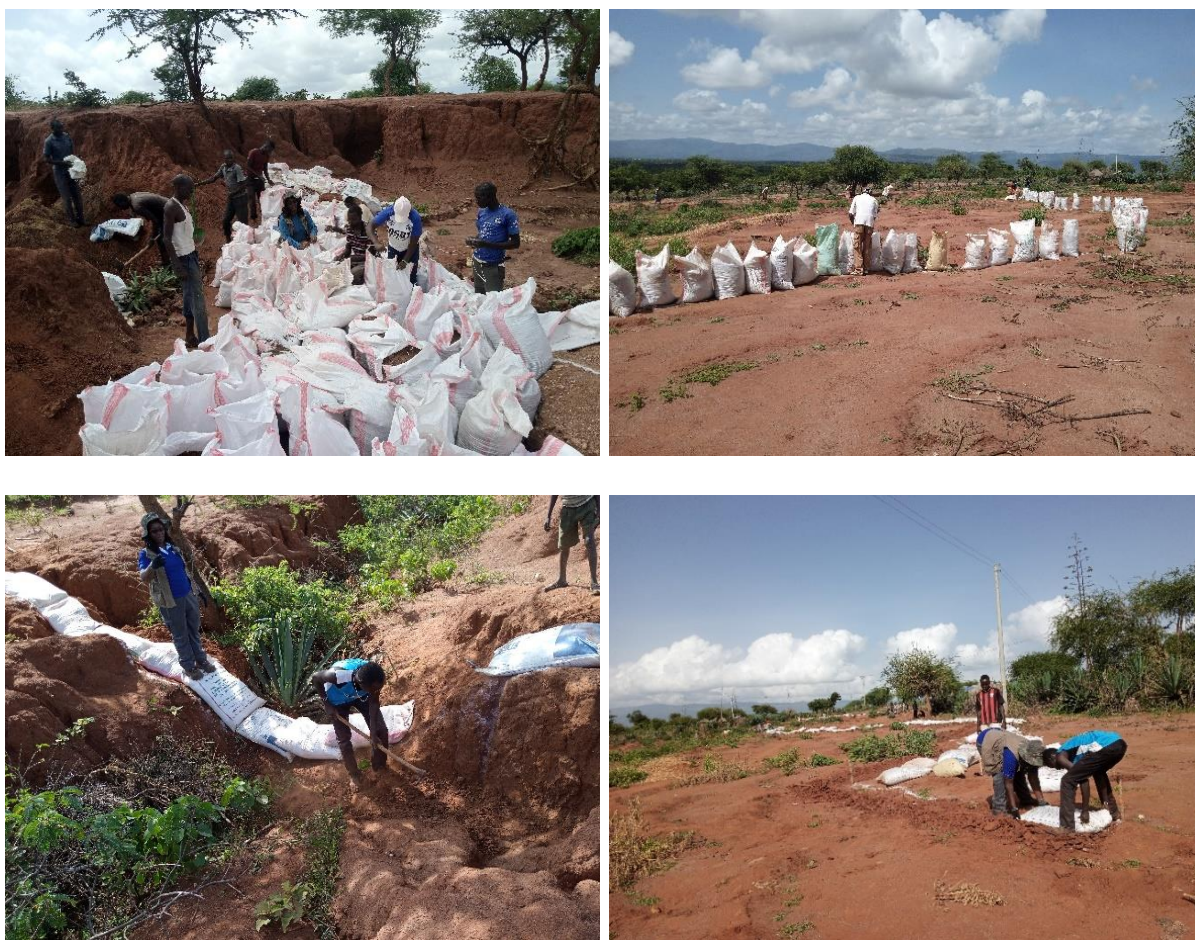
Fig. 6: Filling up of soil bags with the mixtures of sand, soil and manure. Aligning the soil bags along the previously marked contour lines (Photos by M Nyaga).

Members of the community were involved in all the activities and explained to the importance of every activity. They asked many questions and were eager to learn how the huge gullies at the site can be rehabilitated. The ratio of sand, soil and manure used was were 2:3:1. The mixtures were put in the sacks weighing 50kgs and placed horizontally along the previously marked contour lines after leveling the ground (Fig 6). The sacks help in reducing the evaporation of water allowing the vertiver splits to establish. This is important especially in the arid and semi-arid areas where the evaporation rates on bare soils is high.

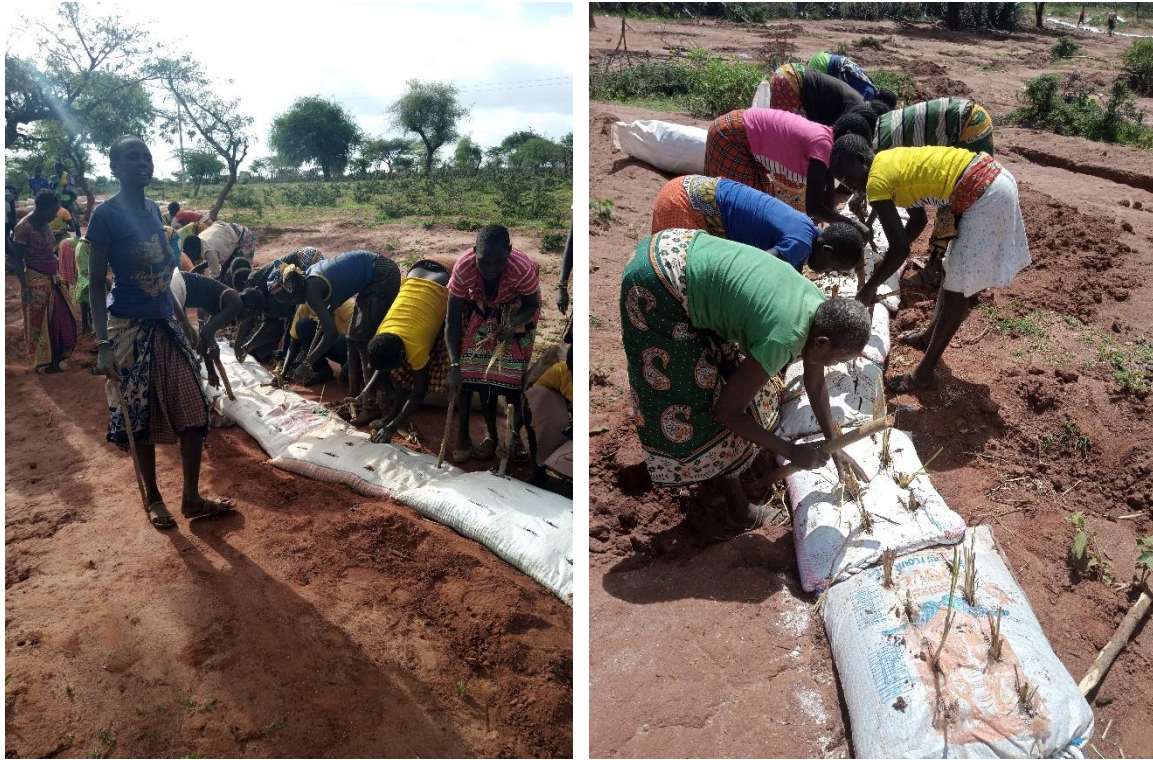
Fig. 7: A group of women planting the Vetiver grass splits in the soil bags (Photos by M Nyaga).

After the soil bags were properly laid onto the marked contour lines and firmly pinned with some wooden pegs, small openings were made using a knife to open up spaces for planting the Vetiver grass (*Chrysopogon zizanioides*) splits. The community members were divided into two groups to plant the grass after active demonstrations (Fig. 7). One of the groups was working at the Livestock Café Main site under the guidance of Jane Wegesa while the other team was at the Livestock Café Annex site under the guidance of Andrew Wekesa.

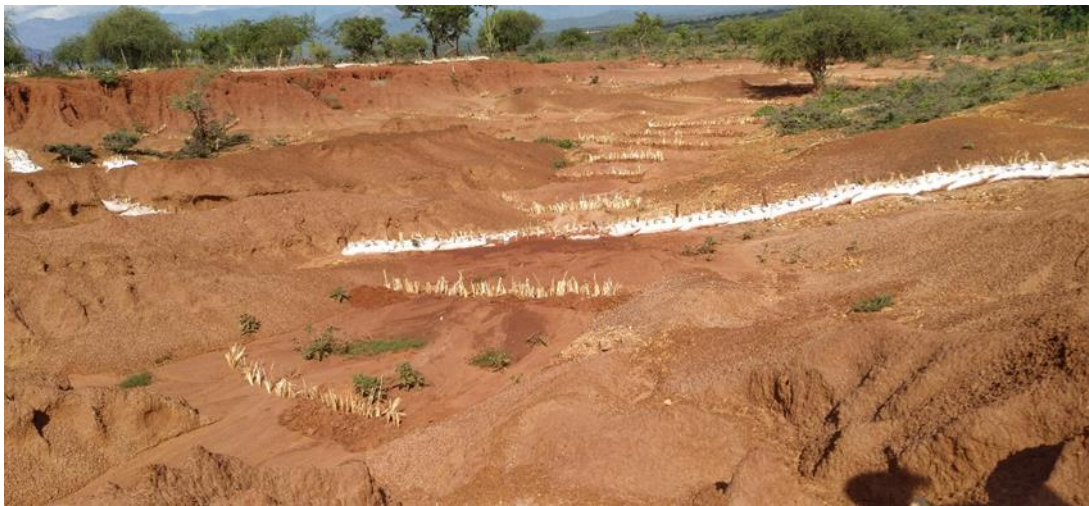
Fig. 8. Vertiver splits planted directly without the bags at the base of the gullies (Photos by M Nyaga).

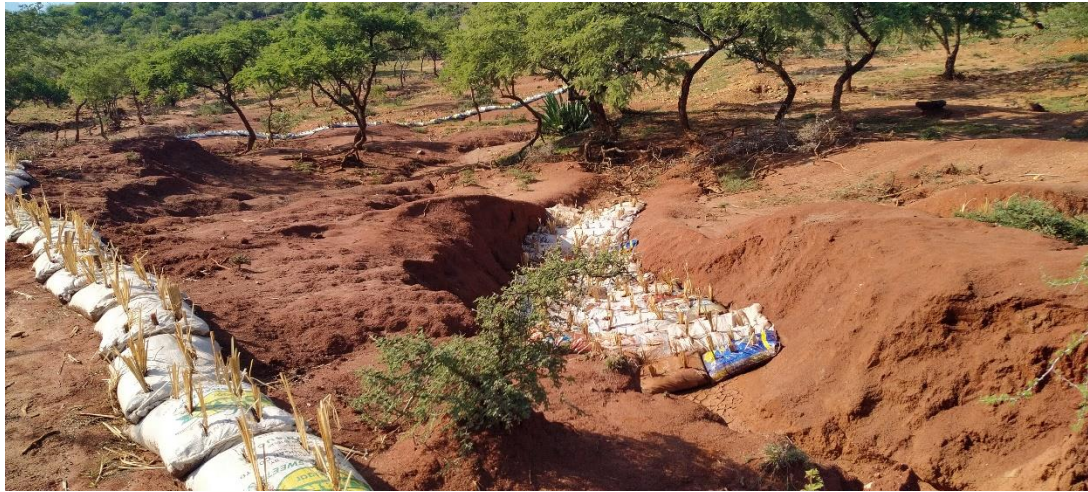
Fig. 9. Vertiver splits planted in the horizontally laid bags along the contour lines and at gully mouth at the Chepareria Livestock Café Annex site (Photos by M Nyaga).

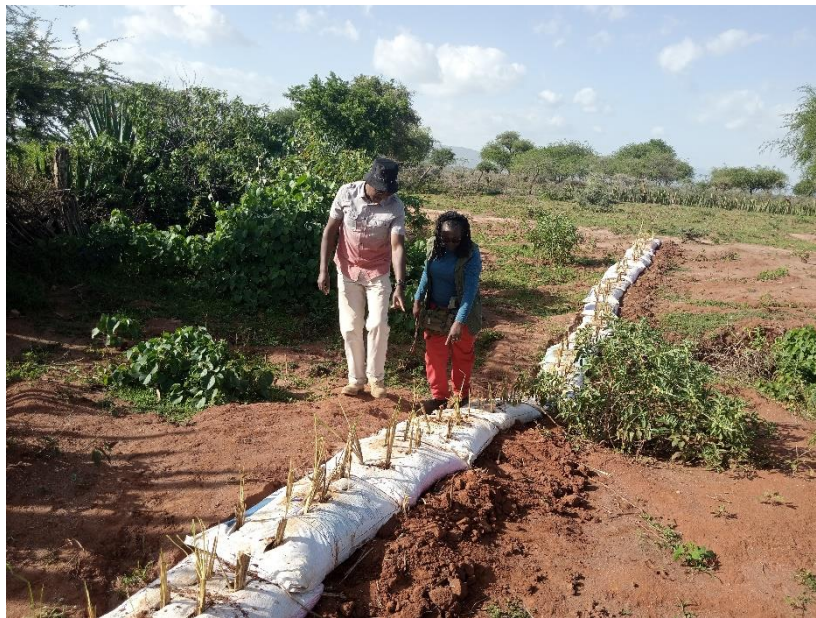
Fig. 10. Dr. Stephen Mureithi and Madam Jane Wegesa inspect the already planted soil bags at the Chepareria Livestock Café Main site (Photos by M Nyaga).

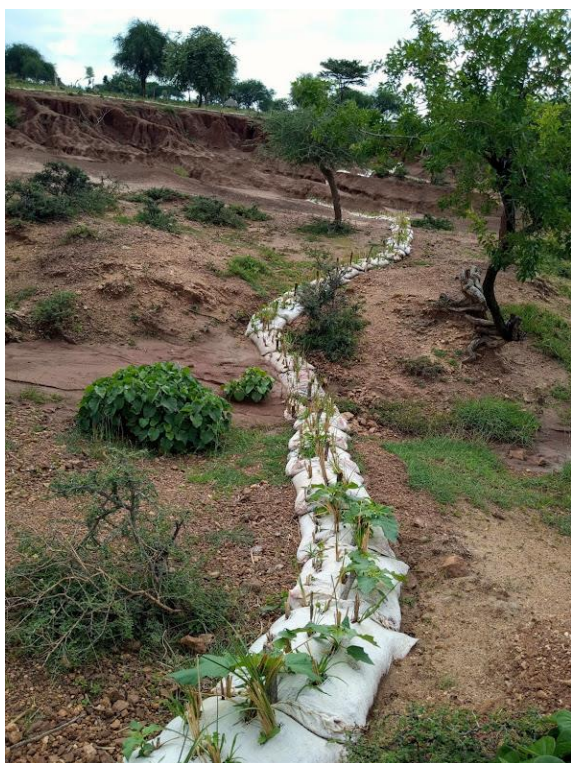
Fig 11. Vertiver splits establishing well after the rains

One week after the planning, rains were received on 8/6/2022 which gave the planted splits a very good start.
